## EVALUATION OF A FORTY-YEAR OLD T.Y. LIN DESIGNED ELLIPTICAL POST-TENSIONED CABLE-SUPPORTED ROOF

**Randall W. Poston**

*Principal, WDP & Associates, Inc.*

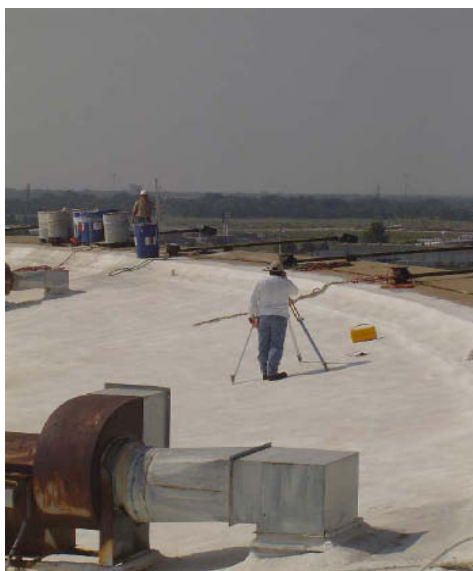
Figure 3. Surveying to determine roof sag.

Based on the differential survey conducted, the roof sag as measured from the edge of the roof to the center was between approximately 17 ft. 4 in. and 17 ft. 8 in. The range is given since the exact thickness of the roof foam at these locations is not known. This measured value was compared to computed values from analysis under dead load only since at the time of the measurements there were no superimposed live loads.

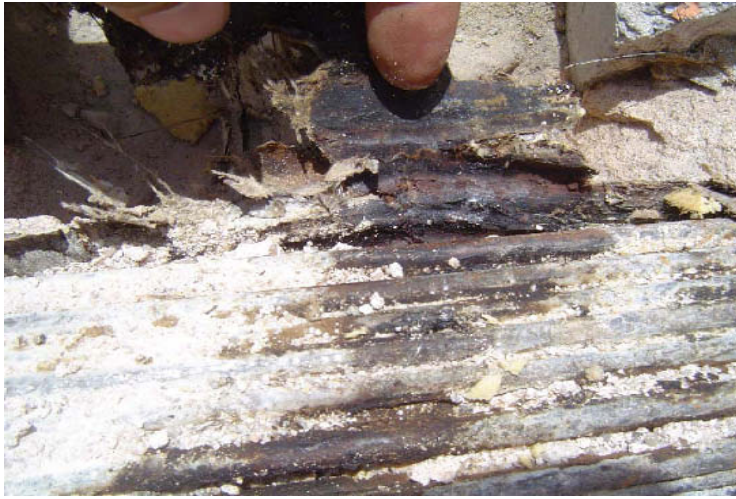
Figure 7 shows a typical condition of the prestressing wires exposed at each tendon opening. The wires generally appeared to be in good condition with only evidence of minor surface corrosion. The dark color of the wires is discoloration principally from the mastic. This minor surface corrosion did not appear "fresh" as would have been evidenced by a bright orange corrosion product. There were no significant corrosion pits indicative of area loss.

The paper wrap, which acts as the unbonded PT duct, has experienced some deterioration as observed in Figure 7. The bitumen mastic that was used to protect the wires from corrosion was variable in thickness and coverage. However, as long as the roofing material prevents water intrusion, the deterioration of the paper duct and presence variable mastic is not considered overly significant.

Figure 7. Typical condition of prestressing wires.

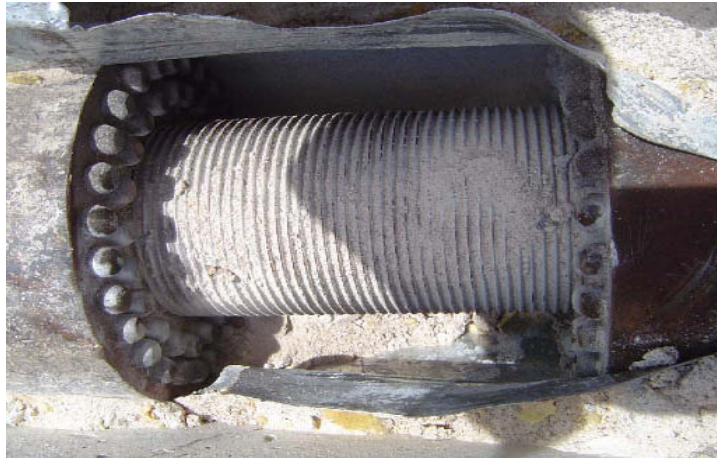
The condition of the exposed coupler along the strong axis tendon is observed in Figure 8. There was little evidence of corrosion of the metal duct that was split open to observe the coupler, threaded rod or anchors. Also note that the “buttons” of each wire are intact and show no evidence of corrosion.

Figure 8. Condition of exposed coupler.

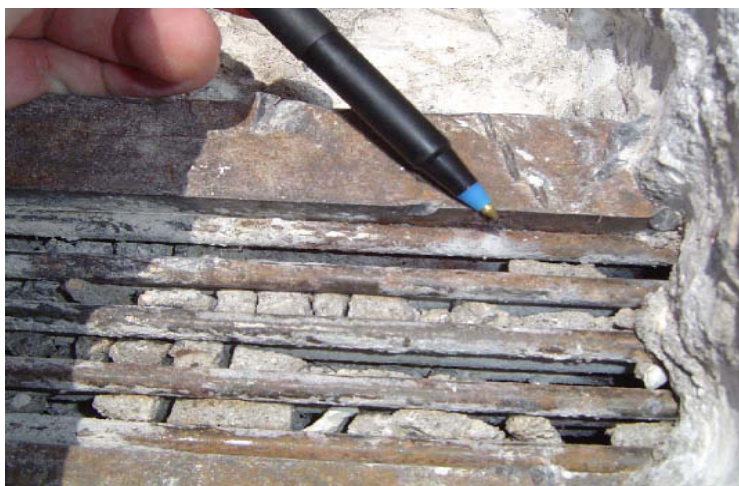
Figure 9 shows the representative condition observed at the exposed anchorages of the PT tendons. The field investigation at the selected anchorages clearly indicated that there has been no significant corrosion of the prestressing wires, bearing plate or transfer plates.

Figure 9. Typical condition of exposed anchorage.

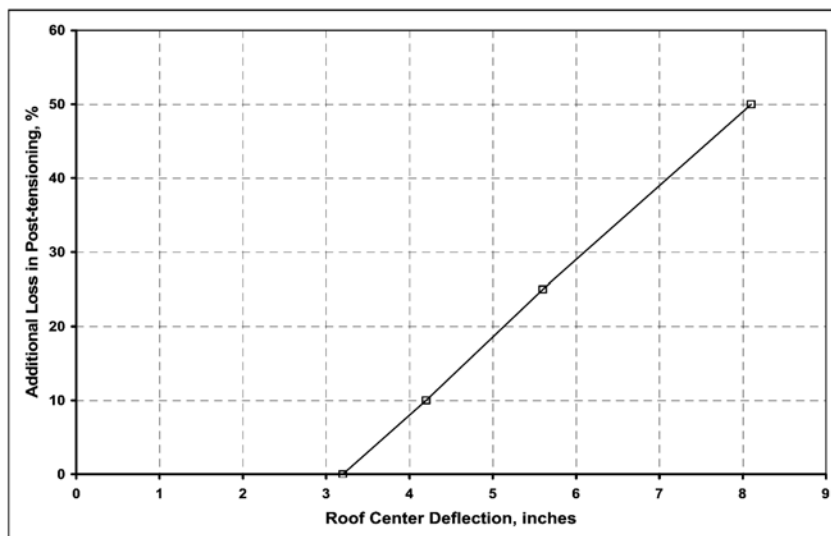
These analyses consider additional losses in the post-tensioning tendons due to some form of deterioration such as corrosion or other factors that might result in a partial loss of prestressing. These additional losses considered were 10%, 25% and 50%, respectively. These losses were applied to the same analysis model and loads of Case 3. The results are summarized in Figure 10. This graph shows that considering 0% losses in the post-tensioning, the deflection in the middle of the roof is about 3.2 in., whereas, 50% losses in the effective post-tensioning stress results in a deflection of 8.1 in. The analysis indicates that the center deflection of the roof is not overly sensitive to assumed losses in the post-tensioning from some form of deterioration. The increase in roof deflection is linear with the percentage of prestressing losses.

Figure 10. Deflection at middle of roof compared to assumed additional losses in post-tensioning.
