## IN-PIPE GROUND PENETRATING RADAR FOR NON-DESTRUCTIVE EVALUATION OF PVC LINED CONCRETE PIPE

Samuel T. Ariaratnam<sup>1</sup> and Noel Guercio<sup>2</sup>

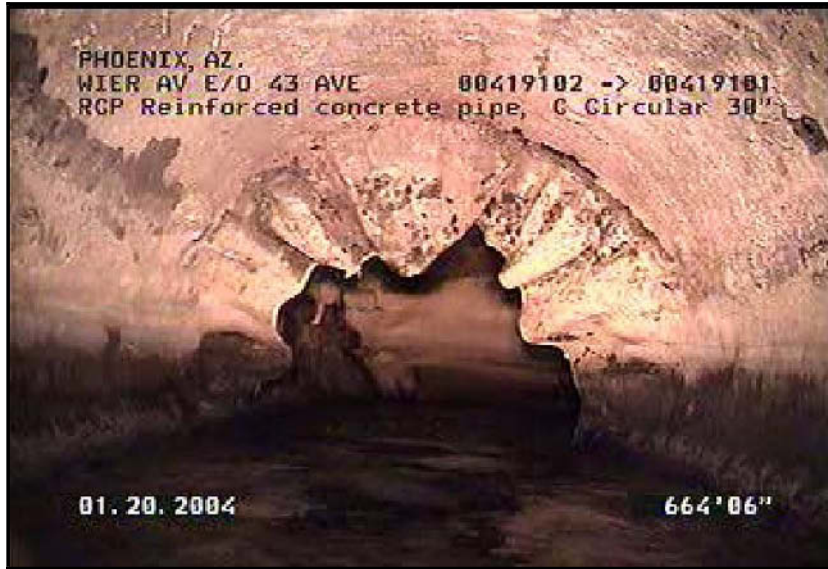
Figure 2. Detached liner

Various defects were observed during the CCTV visualization inspection. Condition assessment of the results found that a total of 537 out of 2,451 total defects (22%) were considered to be minor and given a condition grade of 1. Subsequently, these were omitted from the pipe segment ratings and the subsequent tables and figures. Common defects observed during the CCTV inspection included pinholes in the liner, blisters in the liner, detached weld strips, and holes in the liner. Several of these defects are illustrated in Figure 2. A breakdown of the Grade 2 through 5 defects is presented in Table 2.

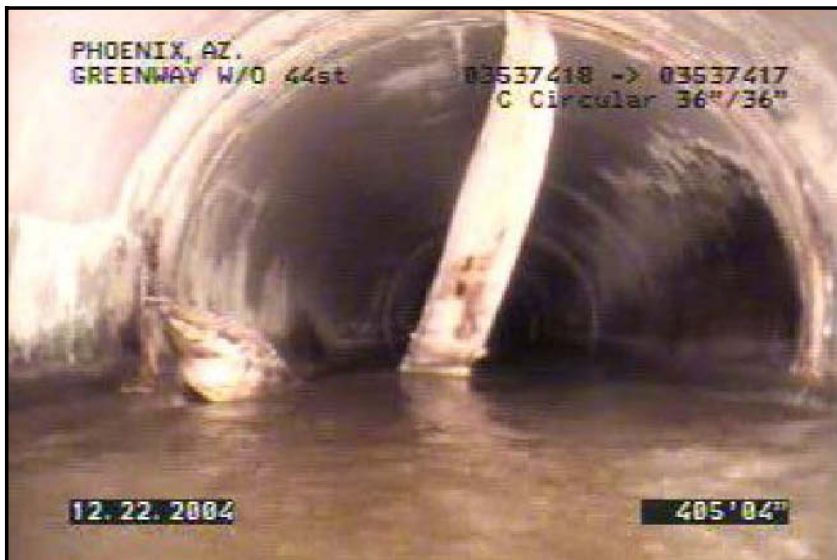
Figure 3. Detached weldstrip

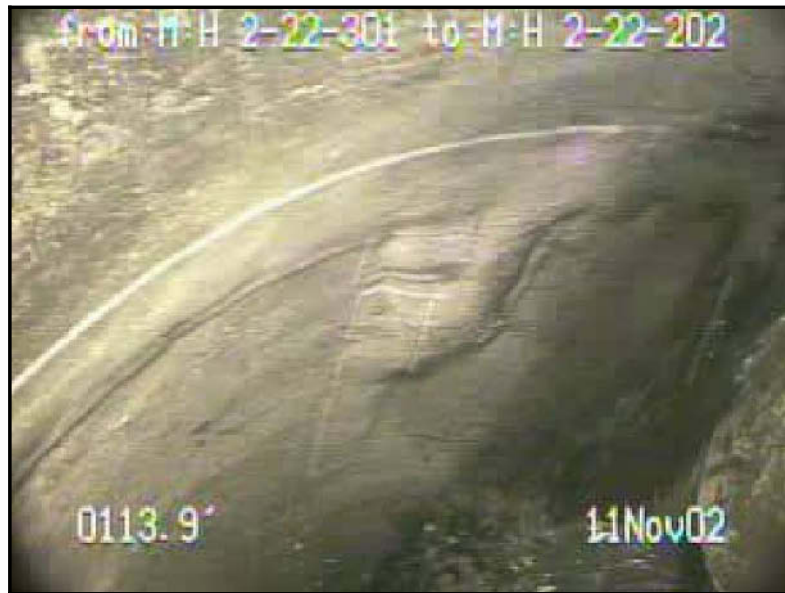
**Figure 4.** Blister in liner

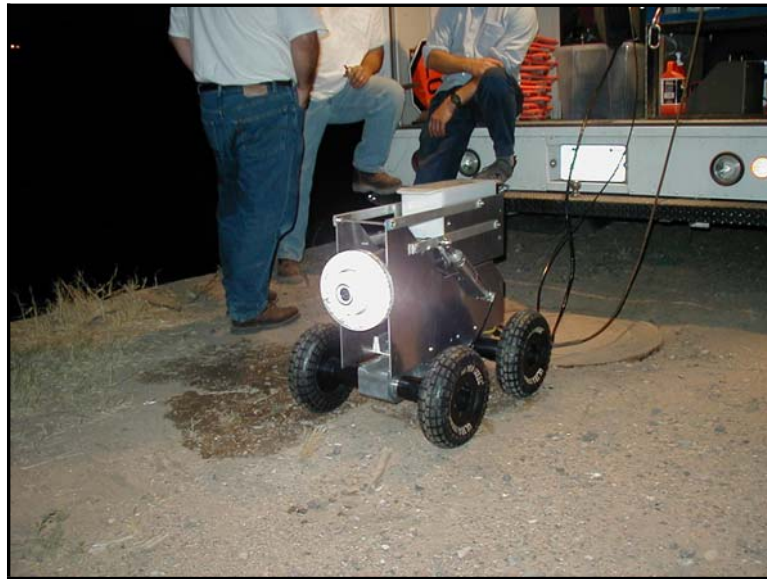
**Figure 6.** Second generation wheeled inspection robot with gpr

Due to the pipe size and potential flow conditions, it was determined to use a wheel robotic body rather than the track body used in the Japanese field tests. The second generation robot, illustrated in Figure 6, capture data behind the liner at pre-positioned liner defect positions along several pipeline sections. Unfortunately, a limitation was the fact that information could only be captured at the 12 o'clock position due to the fixed GPR unit.

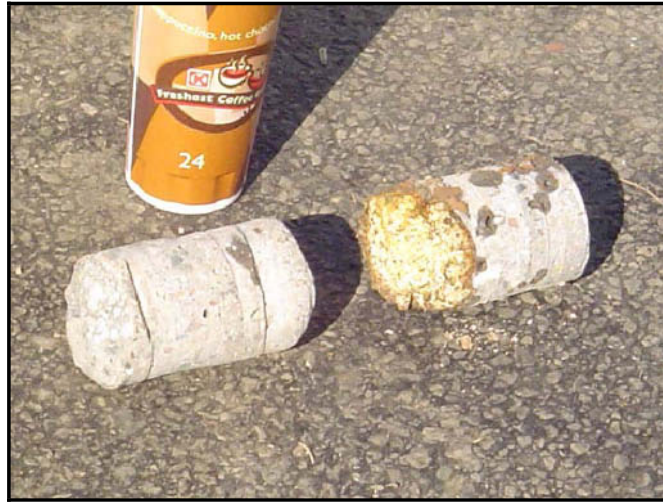
**Figure 9.** Core samples from 750 mm concrete pipe section

Core samples of pipe walls were obtained from two different locations to provide a visual verification of suspected problem areas detected by the ground penetrating radar. In both locations, a 5 m deep, 2.4 m wide, 7.6 m long trench was excavated at predetermined locations with a box shoring used for stabilization. A GPR survey was performed on the exterior surface of the top of the reinforced concrete pipe to determine the exact location to extract the coring sample. Two 75 mm diameter samples were recovered at each of the two locations and preserved for laboratory testing of compressive strength (Edwards and Nowaczyk, 2005). One sample was at a suspected defect location, while the other was in an unaffected section of the concrete pipe wall for comparison. Table 3 presents the results of the compressive strength tests performed to ASTM C39-01 standards.

The cores samples (Figure 9) verified the results found using the non-disruptive in-pipe ground penetrating radar unit transported on a robotic platform. Discoloration of the core samples and diminished compressive strength measures further demonstrate the problems that could occur if hydrogen-sulfide gases were to penetrate the liner and attack the concrete wall.
