## Standard Guide for Selection of Structural Details for Ship Construction<sup>1</sup>

The principal aim of this guide is to depict recommended practices related to the design of ship structural details. The importance of structural details is clear:

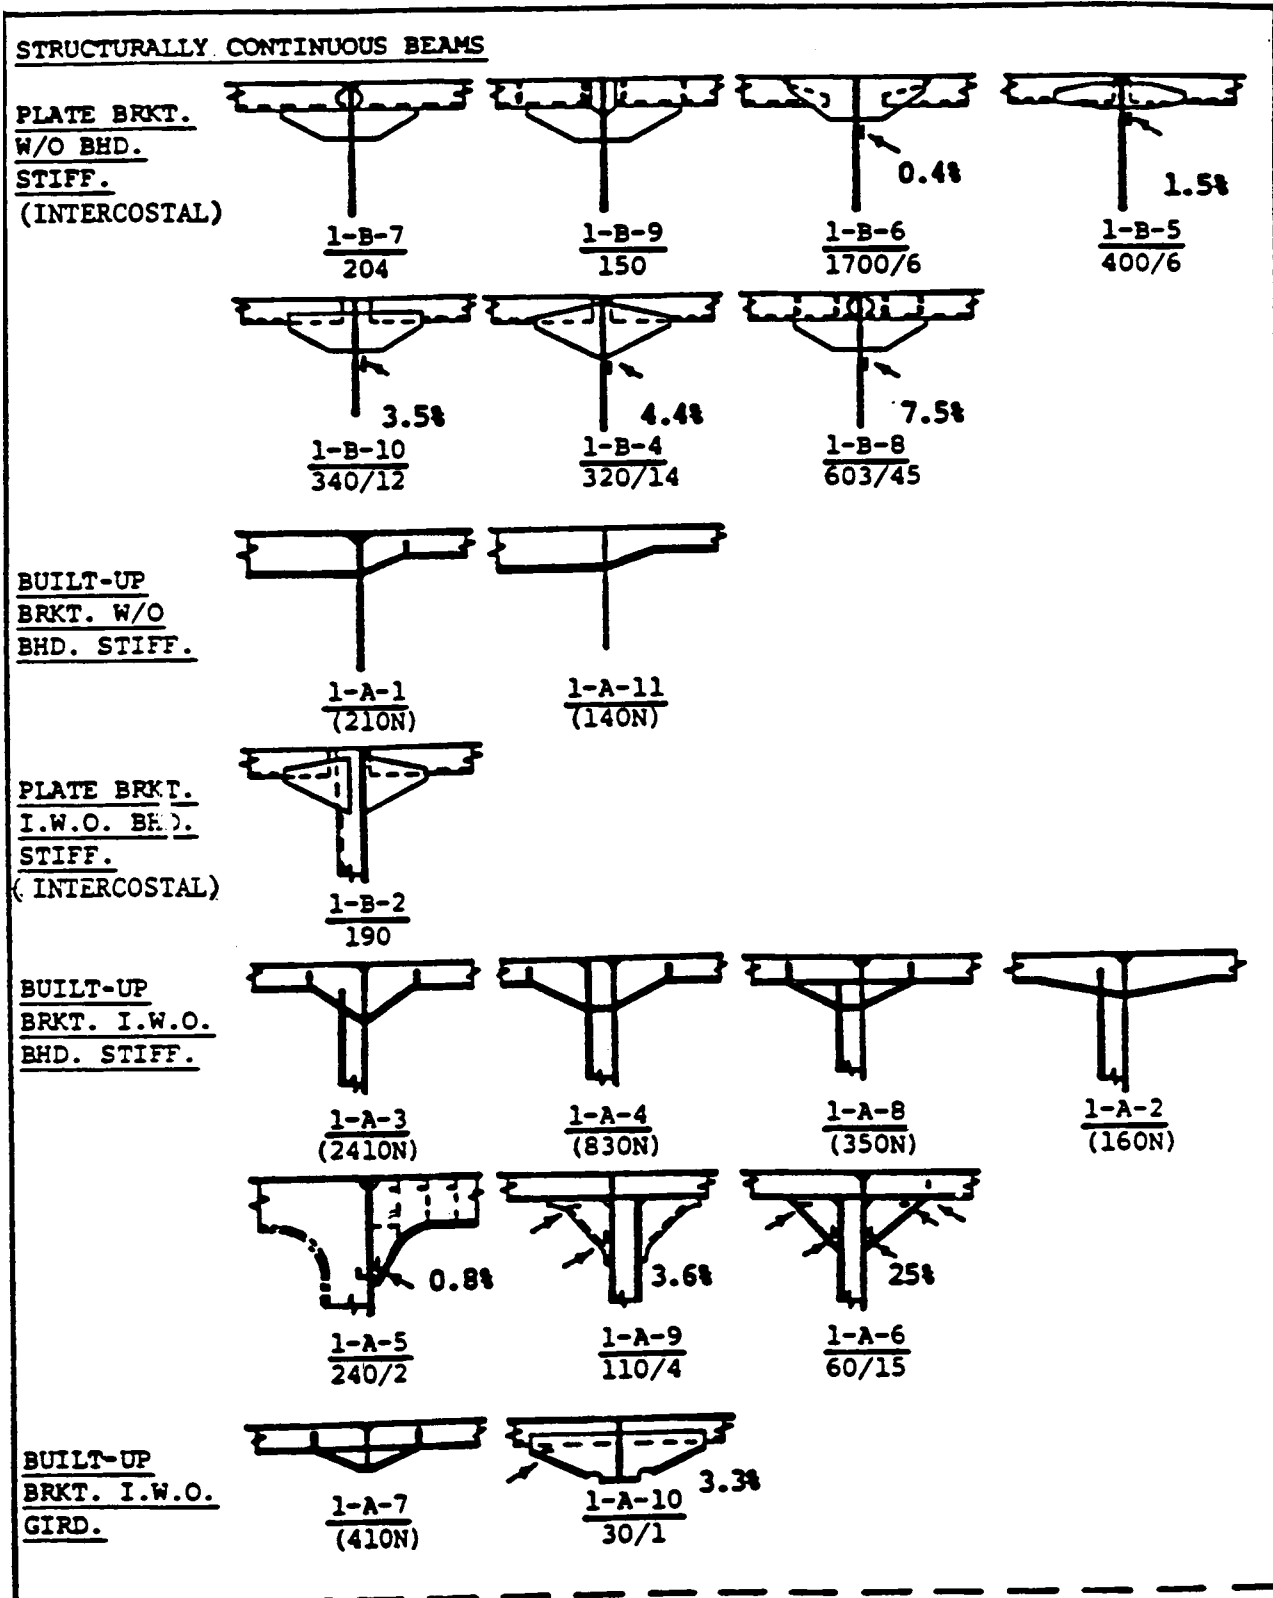
FIG. 14 Performance of Beam Bracket Details (Family No. 1)

4.1.1.3 In the beam bracket configurations of family no. 1 (Fig. 14), 20 % of the surveyed failures attributed to design were caused by instability of the plate bracket edge or by instability of the plate bracket panel. This elastic instability, which resulted from loads that produce critical compressive or shear stresses, or both, in unsupported panels of plating, can be eliminated when properly considered in the design process.

4.1.1.4 The failures of beam brackets by cracking occurred predominately where face plates had been sniped, at the welded connections, at the ends of the brackets, at cutouts in the brackets, and where the brackets were not properly backed up at hatch ends. The sniping of face plates on brackets prevents good transition of stress flow, creates hard spots and produces fatigue cracks due to the normally cyclic stresses of these members. Care must be taken to ensure proper transition with the addition of chocks, back-up structure, reinforcement of hole cuts, and the elimination of notches.

4.1.5.3 The most prominent detail failures attributed to operations were to family no. 1 beam brackets, (Fig. 14). Of the beam bracket failures 67 % were attributed to operation (heavy weather). Possible fixes for the beam brackets included the use of face plates or panel stiffeners to increase panel stability, the use of heavier plating to increase the corrosion margin and

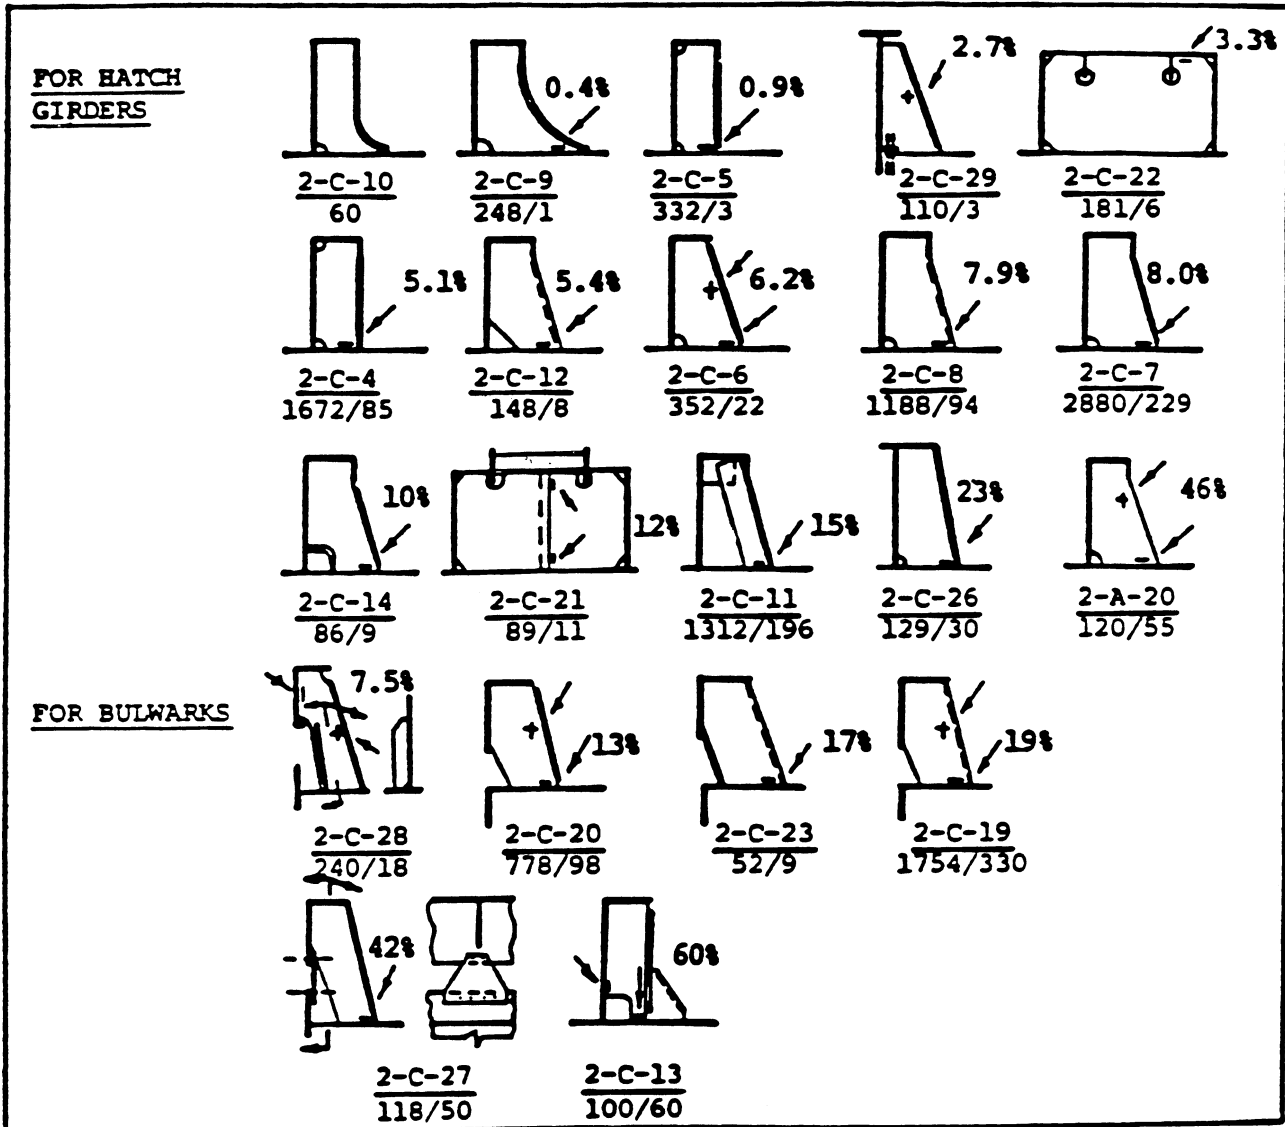
FIG. 19 Performance of Tripping Bracket Details (Family No. 2) Cont'd

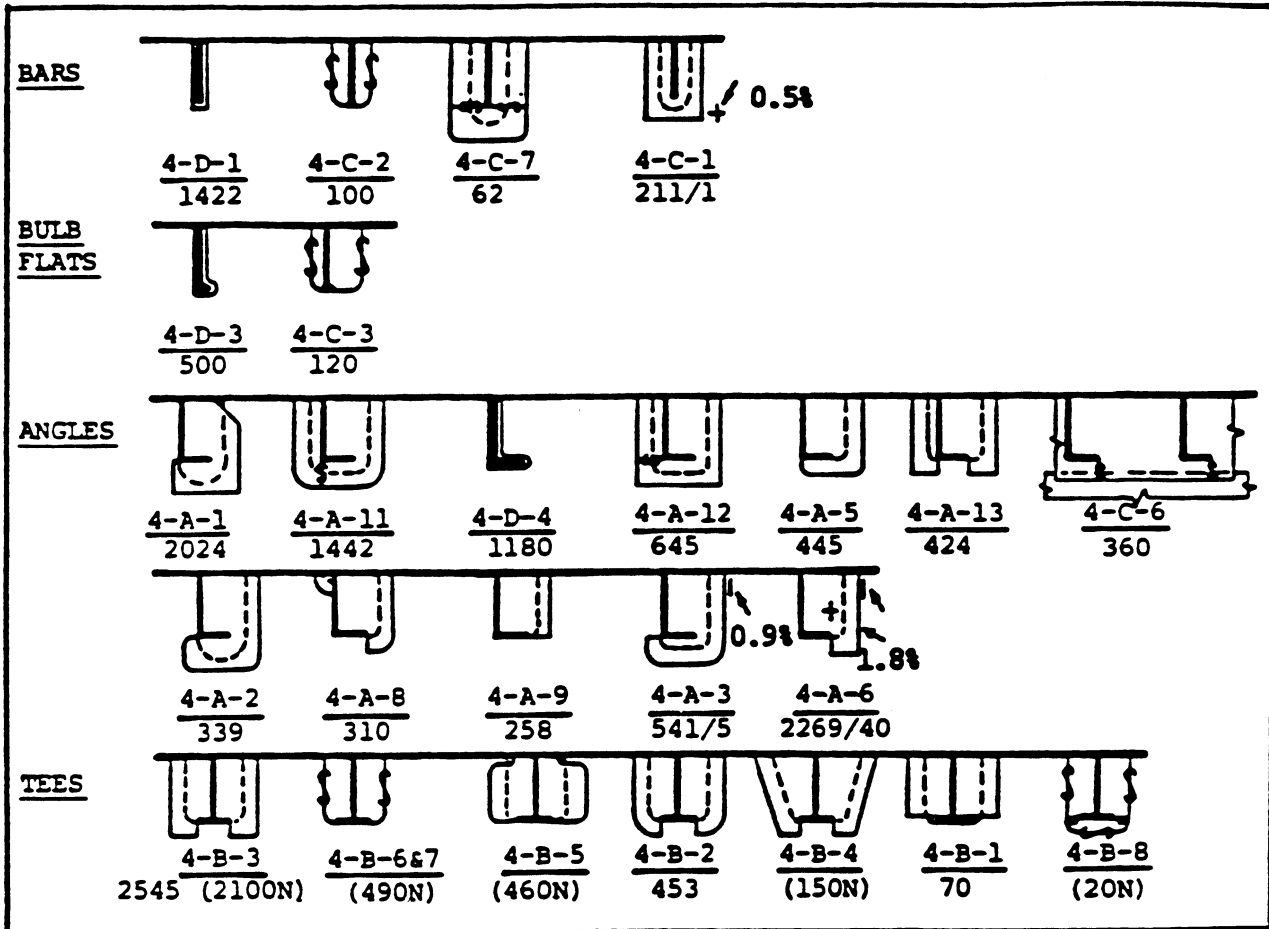
FIG. 22 Performance of Tight Collar Details (Family No. 4)

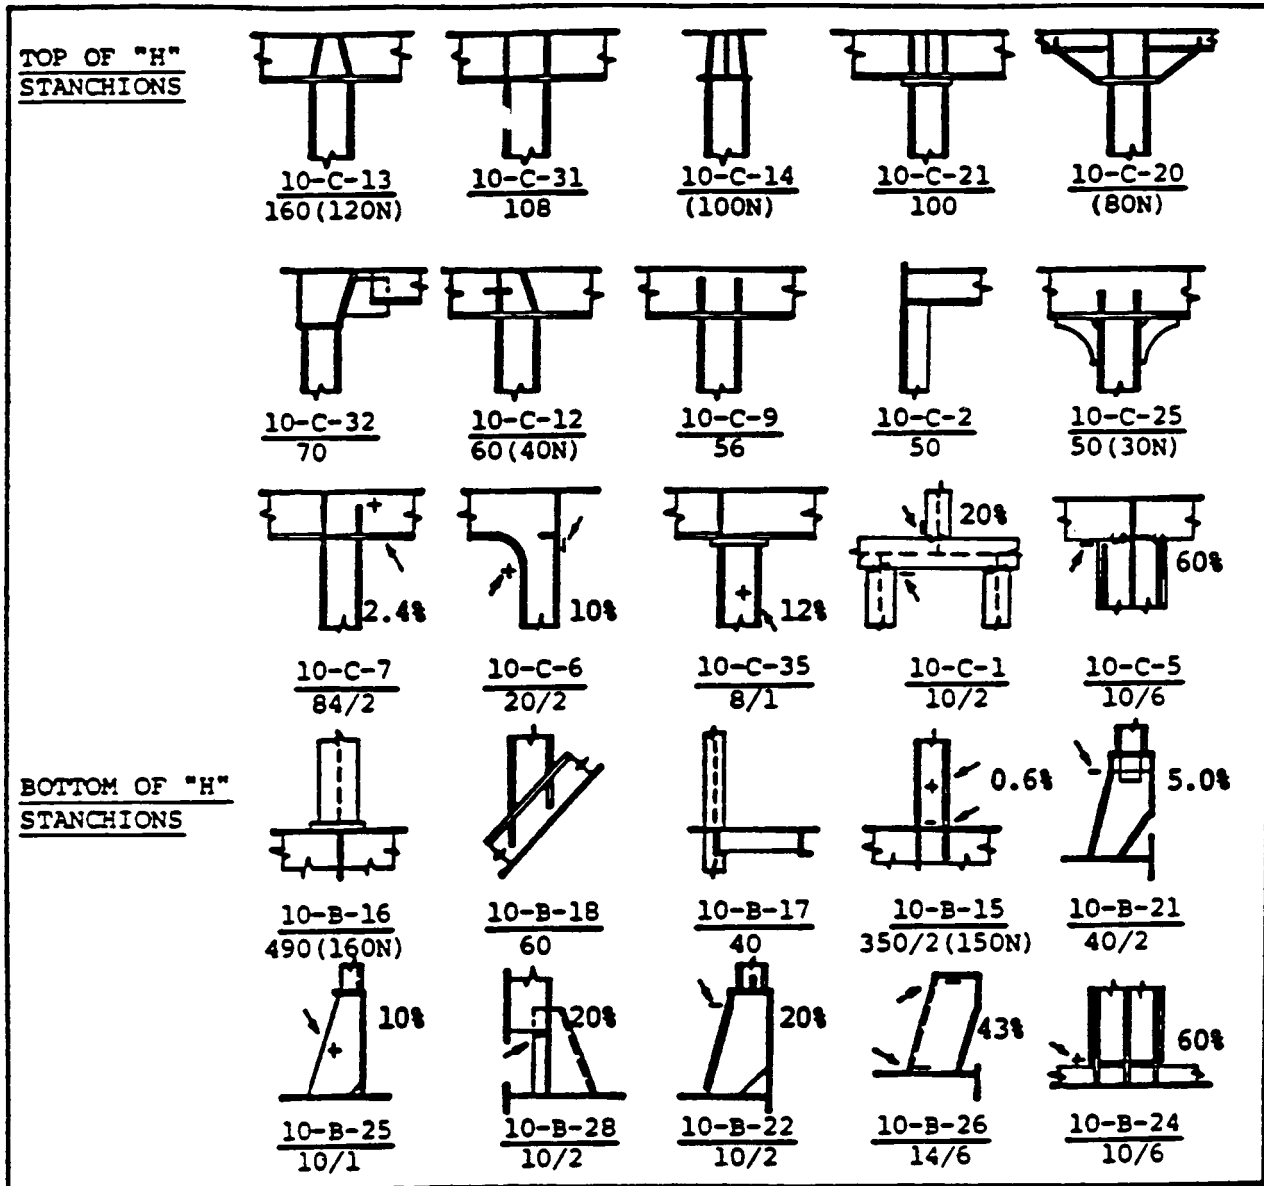
FIG. 26 Performance of Stanchion End Details (Family No. 10) Cont'd

4.1.1.13 In general, failures in stanchion ends, family no. 10 (Fig. 25 Fig. 26), were cracks which developed in or at the connection to the attachment structure. The addition of tension brackets, shear chocks, and the elimination of snipes would reduce the incidents of structural failure. All stanchion end connections should be capable of carrying the full load of the stanchion in tension or compression. Stanchions used for container stands or to support such structure as deckhouses on the upper deck should be attached to the deck with long tapered chocks to reduce stress flows from hull induced loads, and in no case should "V" notches be designed into such connections.

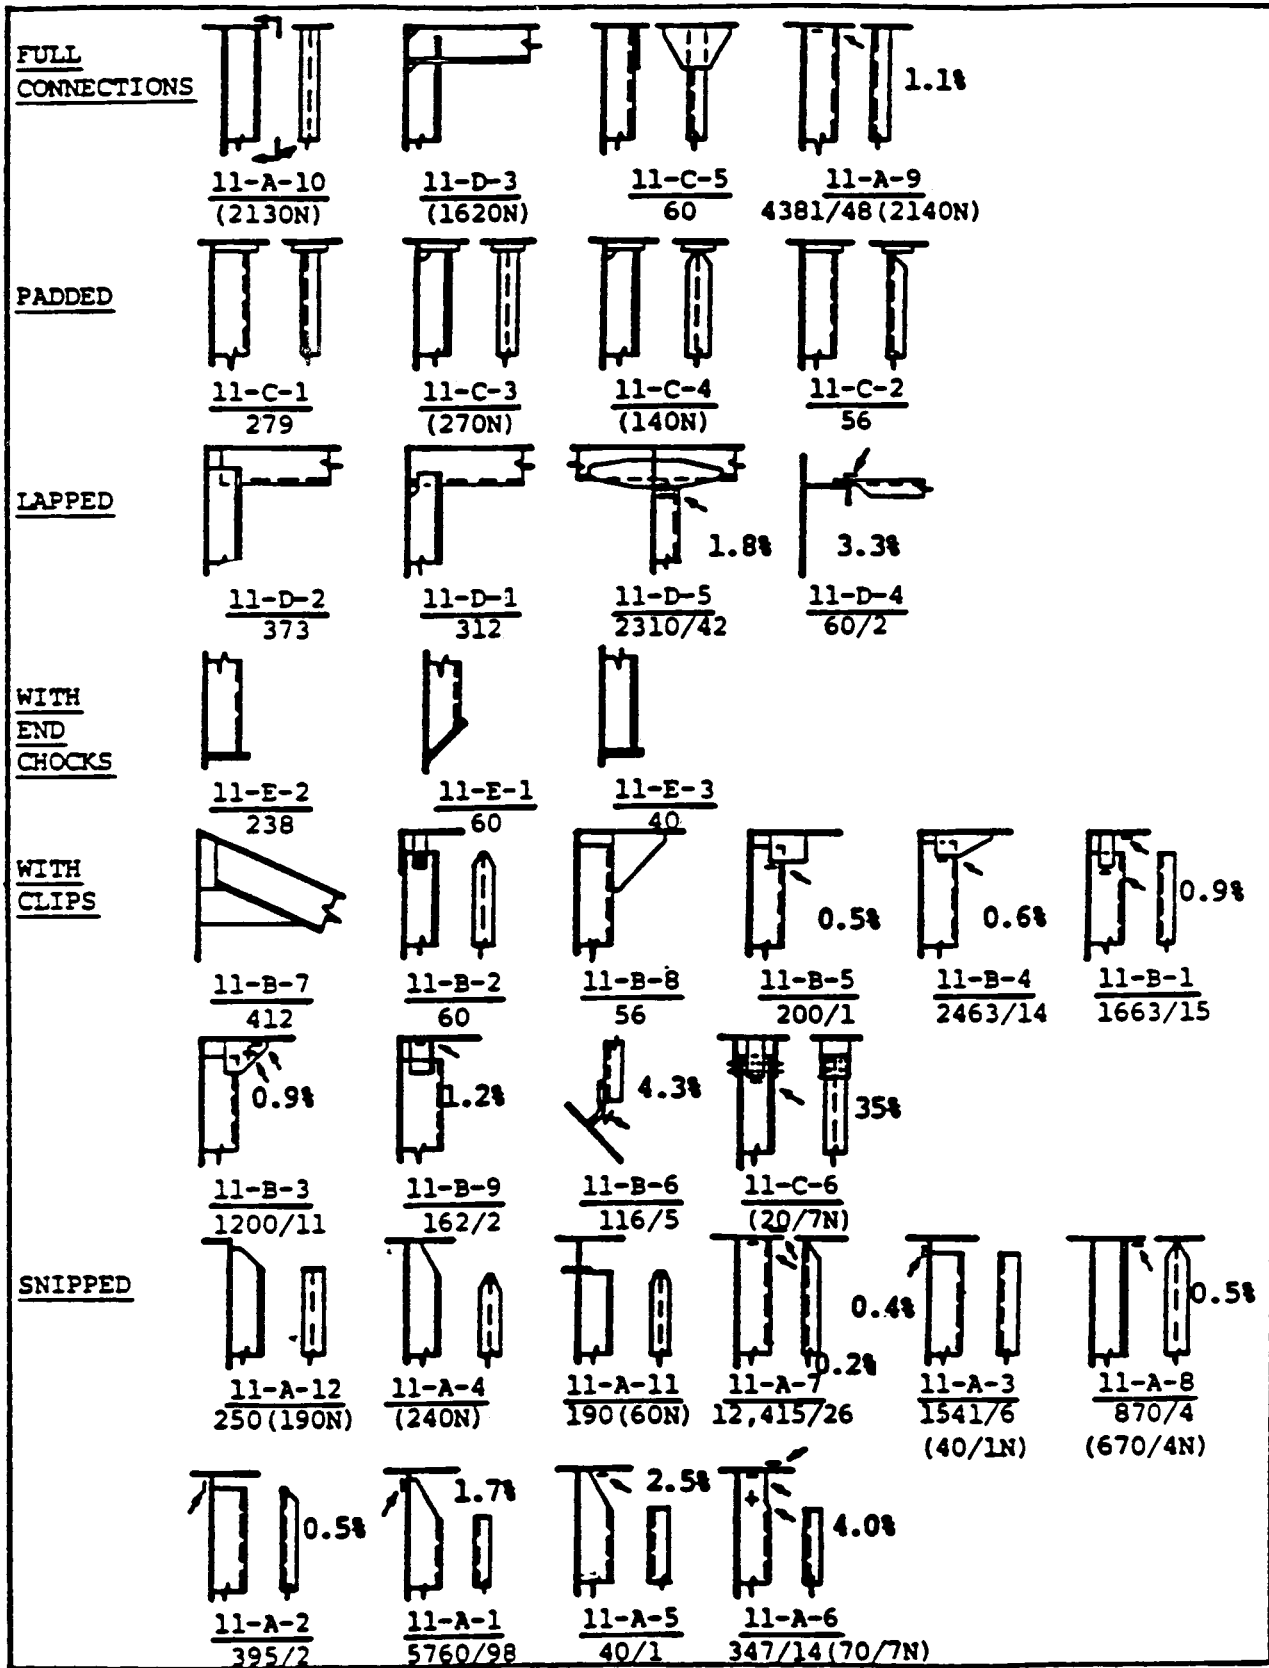
FIG. 27 Performance of Stiffener End Details (Family No. 11)

4.1.1.14 The stiffener ends in family no. 11 (Fig. 27) with webs or flanges sniped, or a combination of both, or square cut ends sustained failures. In nearly all cases, the failures occurred in the attached bulkhead plating, the web connection when the flange was sniped, or the shear clip used for square cut stiffener ends.
