Designation: F 154 – 00

# Standard Guide for Identification of Structures and Contaminants Seen on Specular Silicon Surfaces<sup>1</sup>

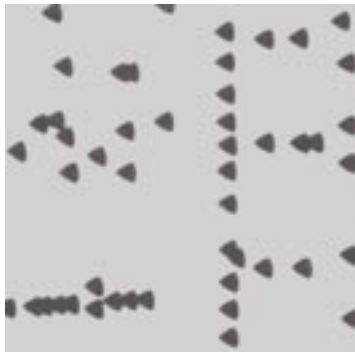
**FIG. 1 Dislocation Etch Pits on (111) Silicon, Following 3-Min Sirtl Etch, Magnification 110×.**

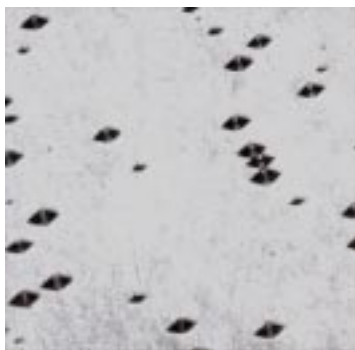
**FIG. 2 Dislocation Etch Pits on (110) Silicon, Following 5-Min Wright Etch, Magnification 110×.**

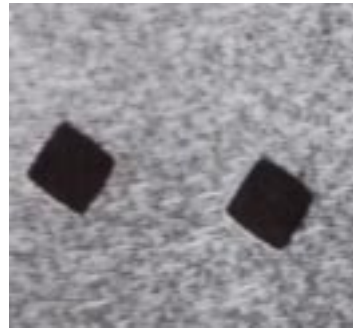
**FIG. 3 Dislocation Etch Pits on (100) Silicon Following Schimmel (B) Preferential Etch, Magnification 320×.**

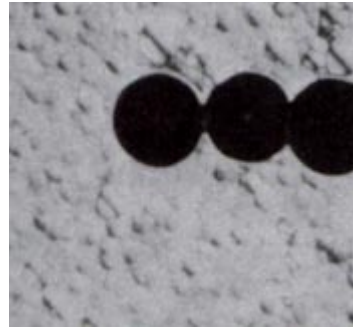
**FIG. 4 Dislocation Etch Pits on (100) Silicon Following Sirtl Etch, Magnification 400×.**

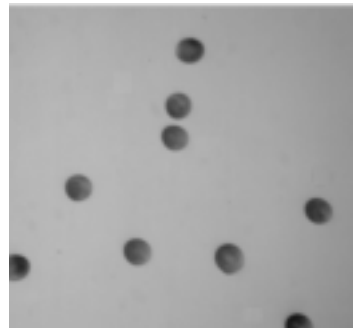
**FIG. 5 Dislocation Etch Pits on (100) Silicon Following 5-Min Wright Etch, Magnification 200×.**

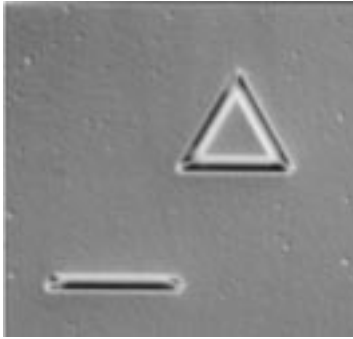
FIG. 6 Epitaxial Stacking Faults on (111), No Preparation Required, Size Dependent Upon EPI Thickness.

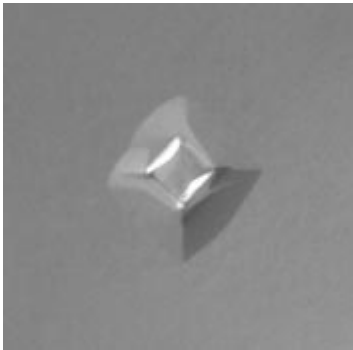
FIG. 7 Epitaxial Stacking Faults on (100), No Preparation Required, Size Dependent Upon EPI Thickness.

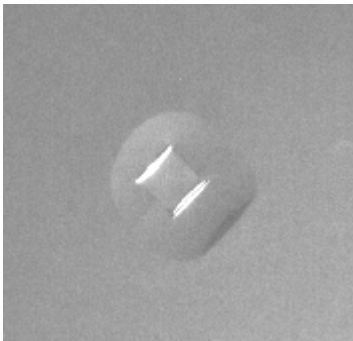
FIG. 8 Epitaxial Stacking Faults on (100), No Preparation Required, Size Dependent Upon EPI Thickness.

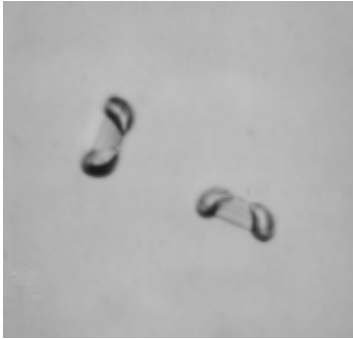
FIG. 12 Oxidation Induced Stacking Faults on (100) Silicon Following Oxidation and 4-min Wright Etch, Magnification 200 $\times$ .

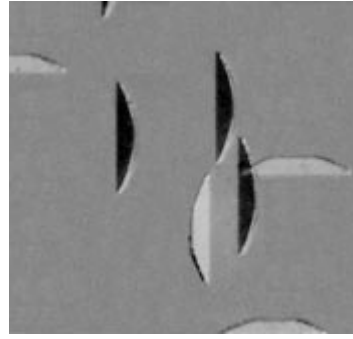
FIG. 15 Oxidation Induced Stacking Faults on (100) Silicon Following Oxidation and 3-Min Secco Etch, Magnification 500 $\times$ .

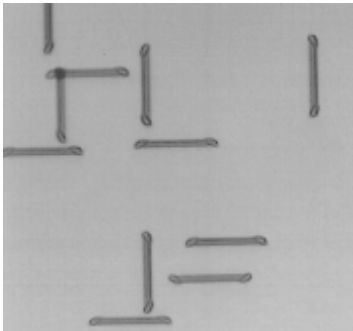
FIG. 13 Oxidation Induced Stacking Faults from Liquid Hone Damage on a (100) Silicon Polished Frontside Surface Following 1100 $^{\circ}$  Oxidation and 1-min Schimmel Etch, Magnification 1500 $\times$ .

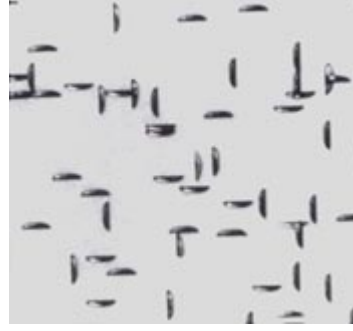
FIG. 16 Oxidation Induced Stacking Faults on (100) Silicon Following Oxidation and 3-min Secco Etch, Magnification 200 $\times$ .

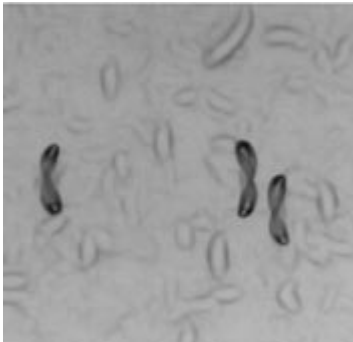
FIG. 14 Oxidation Induced Stacking Faults from Liquid Hone Damage on a (100) Etched Backside Surface Following 1100 $^{\circ}$  Oxidation and 1-Min Schimmel Etch, Magnification 1500 $\times$ .

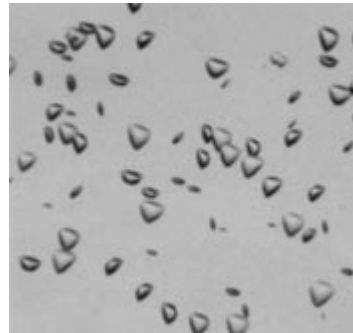
FIG. 17 Oxidation Induced Stacking Faults on (111) Silicon Following Oxidation and 4 Min Wright Etch, Magnification 200 $\times$ .

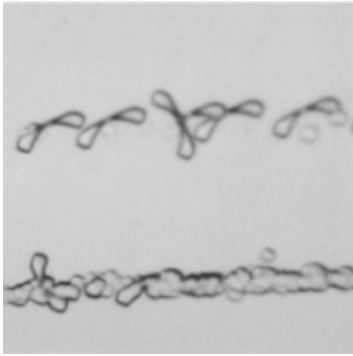
FIG. 18 Oxidation Induced Stacking Faults Caused by a Scratch on (100) Silicon Following Oxidation and 2-min Wright Etch, Magnification 400 $\times$ .

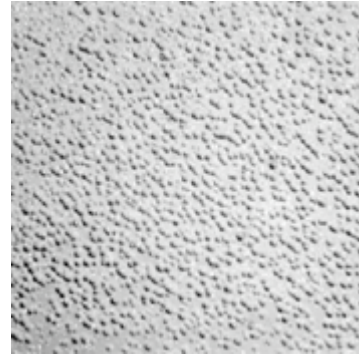
FIG. 21 Relatively Large Shallow Pits on (111) Following Oxidation and 4-Min Wright Etch, Magnification 200 $\times$ .

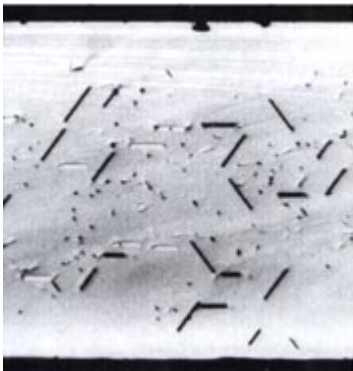
FIG. 19 Oxidation Induced Stacking Faults and Precipitates Found on the Cleavage Face of a Silicon Wafer After Thermal Treatment and 3-Min Secco Etch, Magnification 100 $\times$ .

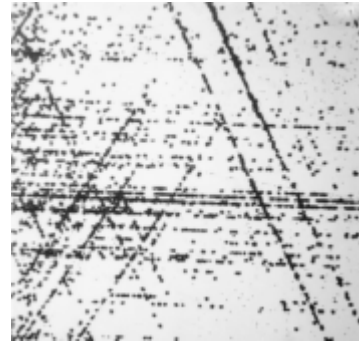
FIG. 22 Slip on a (111) Preferentially Etched Wafer, magnification 5 $\times$ .

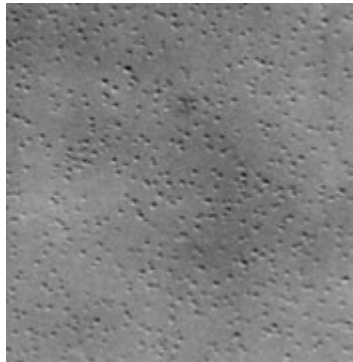
FIG. 20 Relatively Small Shallow Pits on (111) Following Oxidation and 4-Min Wright Etch, Magnification 200 $\times$ .

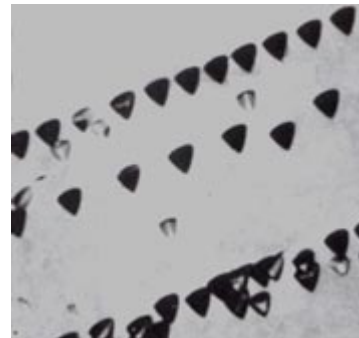
FIG. 23 Slip on a (111) Preferentially Etched Wafer, Magnification 140 $\times$ .

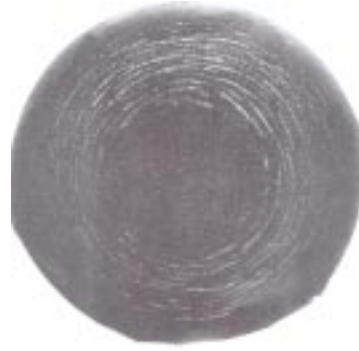
FIG. 27 A-swirl on as Grown Float-Zone Silicon Following Preferential Etch, Full Wafer View.

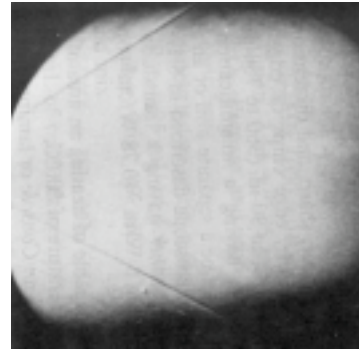
FIG. 28 Twin Lines in a (11) Wafer after Preferential Etching, Full Wafer View.

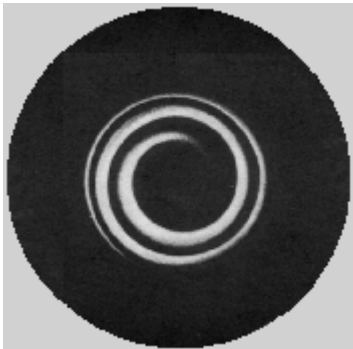
FIG. 26 Swirl Pattern Developed by Preferentially Etching a Czochralski Grown 10 to 20 ohm-cm Lapped Silicon Wafer.

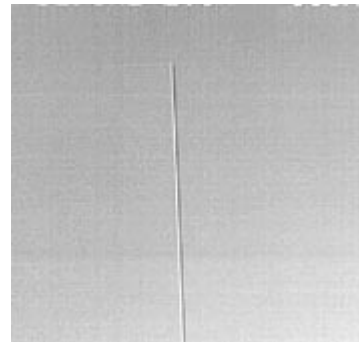
FIG. 29 Twin Line Following 6.5 micron Epitaxial Deposition, No Other Sample Preparation Required, Magnification 300 $\times$ .

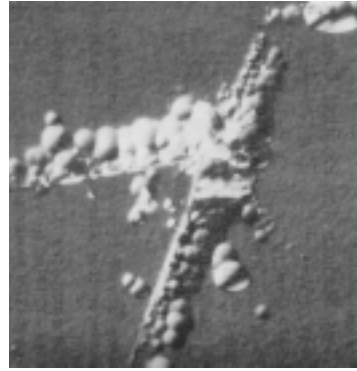
FIG. 33 Crack, Resulting from the Impact on the Wafer Surface, Following Preferential Etch, Magnification 450 $\times$ .

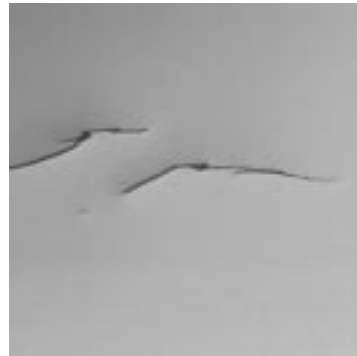
FIG. 35 Crack on a Wafer Surface Due to Mechanical Contact, No Preparation Required, Magnification 750 $\times$ .

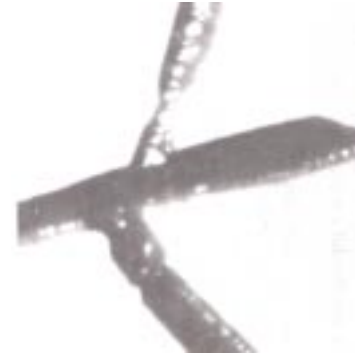
FIG. 40 "Crows-Foot" Crack Resulting from the Impact of a Hard Object with the Wafer Highlighted by Preferential Etch, Magnification 300 $\times$ .

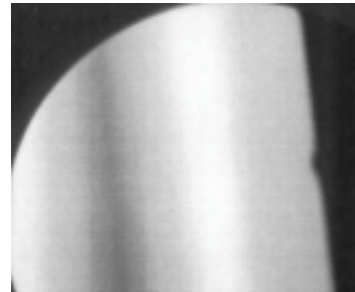
FIG. 41 Dimples Under Fluorescent Lighting Conditions Distort the Reflected Image.

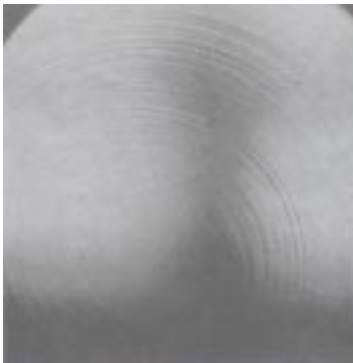
FIG. 43 Dopant Striation Rings after Preferentially Etching, Full Wafer View.

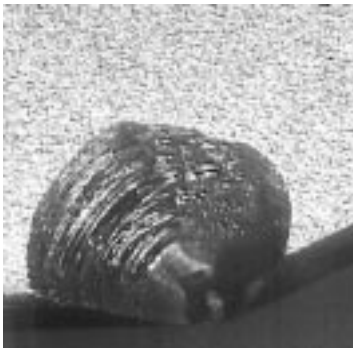
FIG. 44 Relatively Large Chip Found at the End of a Major Flat, No Preparation Required, Magnification 37 $\times$ .

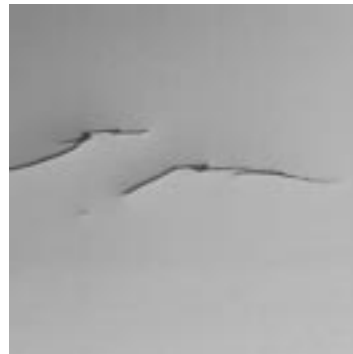
FIG. 47 Relatively Small Edge Chips on a Polished Edge Face, Magnification 200 $\times$ .

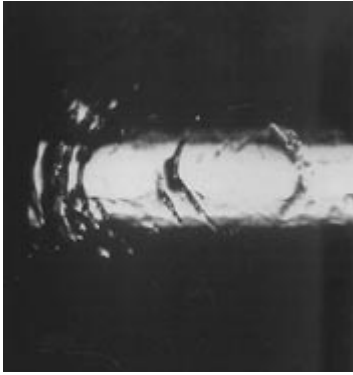
FIG. 48 Edge Cracks on an Edge Face, No Preparation Required, Magnification 200 $\times$ .

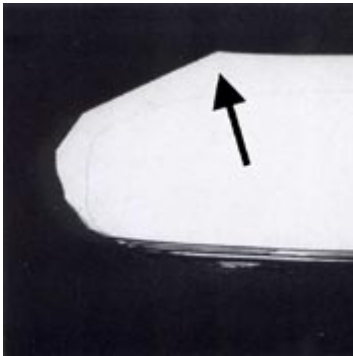
FIG. 49 Vertical Cross Section of Edge Crown on a Cleaved Epitaxial Wafer, Viewed With Low Magnification, Bright Field Microscope.

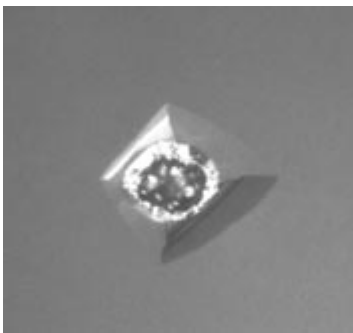
FIG. 50 Epitaxial Large Point Defect, No Preparation Required, Magnification 200 $\times$ .

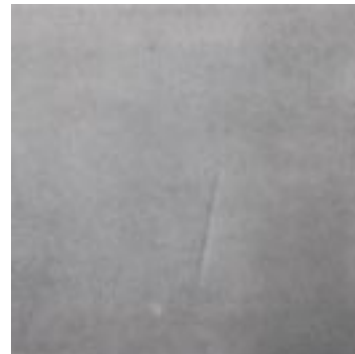
FIG. 53 Groove or Micro-Scratch, Magnification 220 $\times$ .

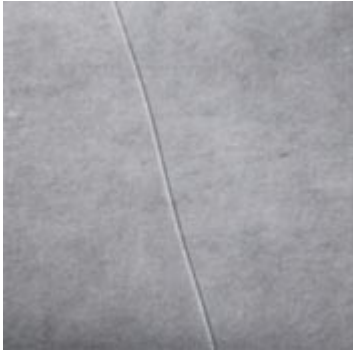
FIG. 54 Groove or Micro-Scratch, Magnification 220 $\times$ .

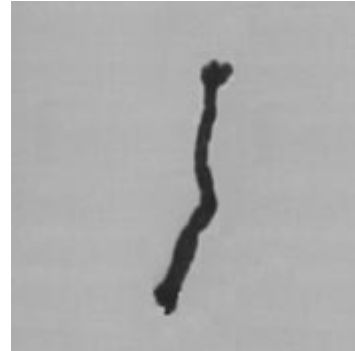
FIG. 57 Localized Lazer Scatterers, (Particle Contamination) in the Form of Small Fiber, Magnification 200 $\times$ .

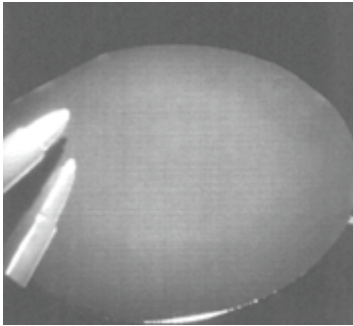
FIG. 55 Haze Seen as Distortion or Blurring of a Reflected Image, Full Wafer View.

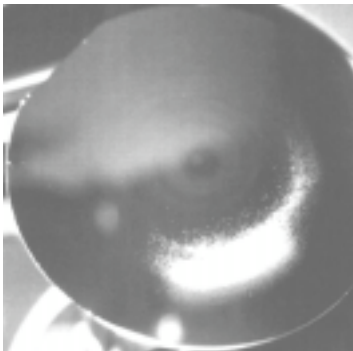
FIG. 56 Haze (Extreme Case) Seen as a White Cloudiness Under High Intensity Light, Full Wafer View.

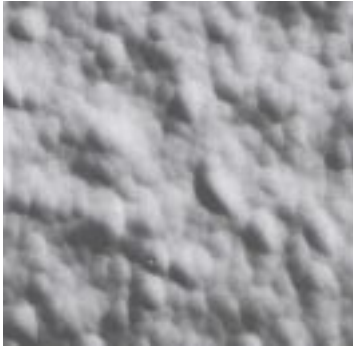
FIG. 60 Orange Peel Surface Roughness, Magnification 200×.

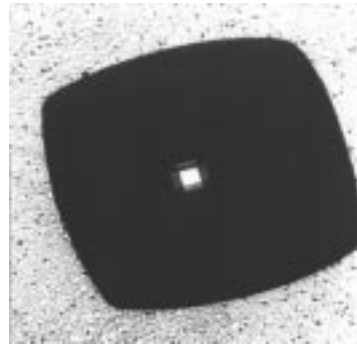
FIG. 63 Pit Associated With a Crystal air pocket on Lapped Wafer. Air pocket size Ranges from a Few microns to a Few Hundred Microns.

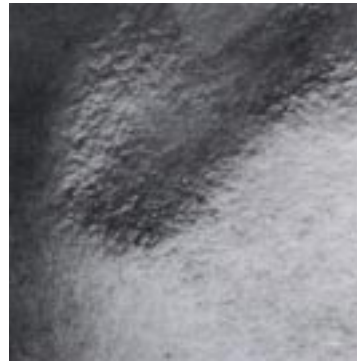
FIG. 64 Saw Blade Defect Seen on Lapped and Etched Wafer, Magnification 6×.

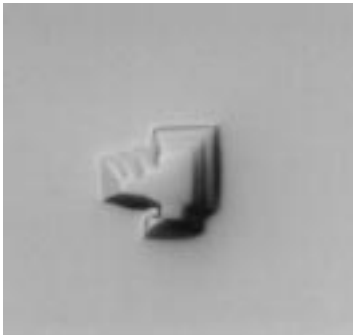
FIG. 62 Pit (Usually Associated With Insufficient Polishing of Caustic Etched Wafer), Magnification 1000×.

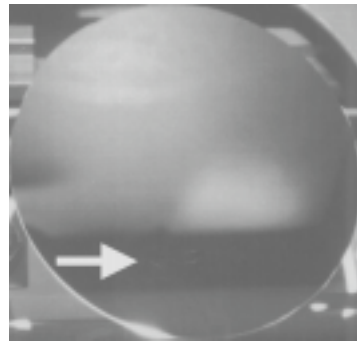
FIG. 65 Multiple scratches (located by the arrow) seen under high intensity light, full wafer view.

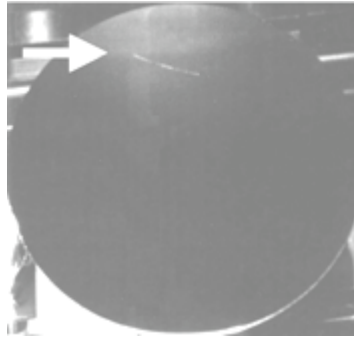
**FIG. 66 A single long arc scratch (located by the arrow) seen under high intensity light, full wafer view.**

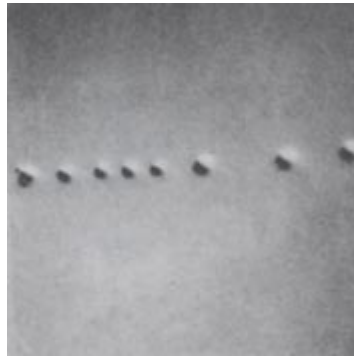
**FIG. 67 Scratch Resulting in a Series of Pits Following Chemical Etching, Magnification 70 $\times$ .**

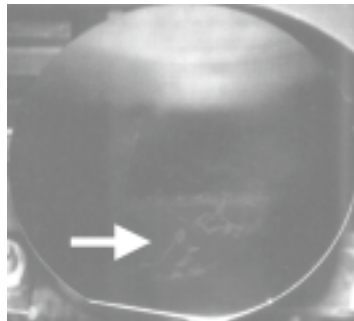
**FIG. 68 Stains from Improper Cleaning or Drying (Located by the Arrow) Seen Under High Intensity Light, Full Wafer View.**
