UIC Code

**5 6 4 - 1**

**Coaches**

**Windows made from safety glass**

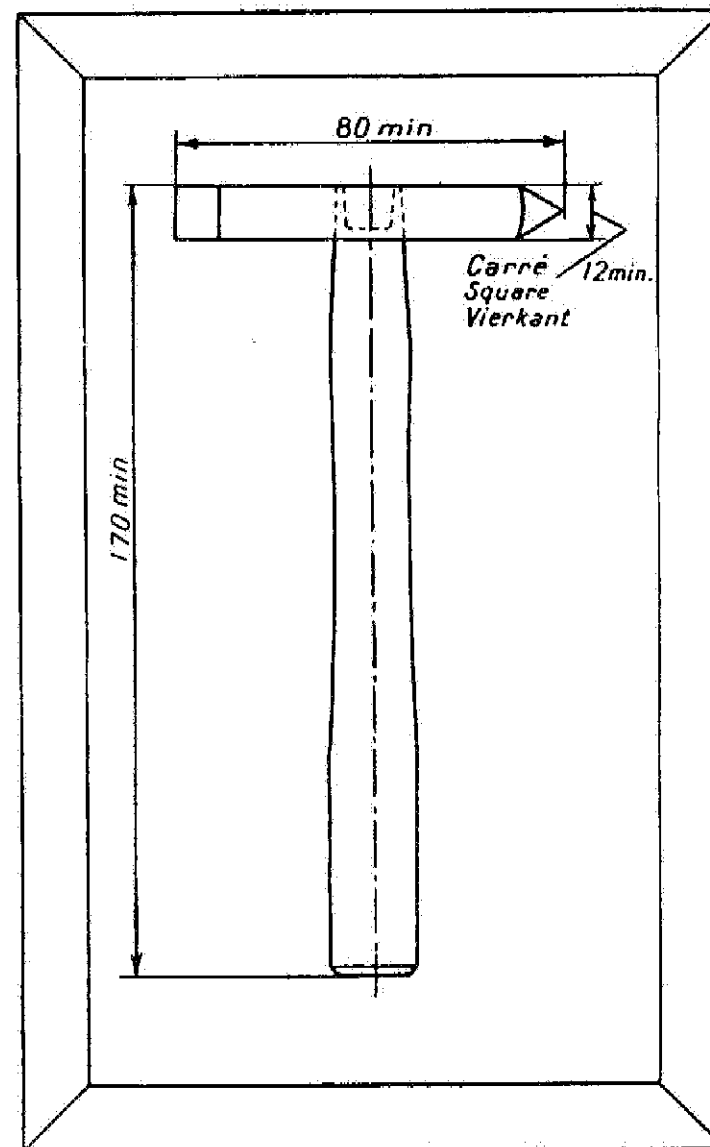
Marteau brise-vitres - Nothammer -

Emergency hammer for breaking the windows

5.3 - the position of the hammer should be easy to locate, even were the lighting system to fail. This can be achieved:

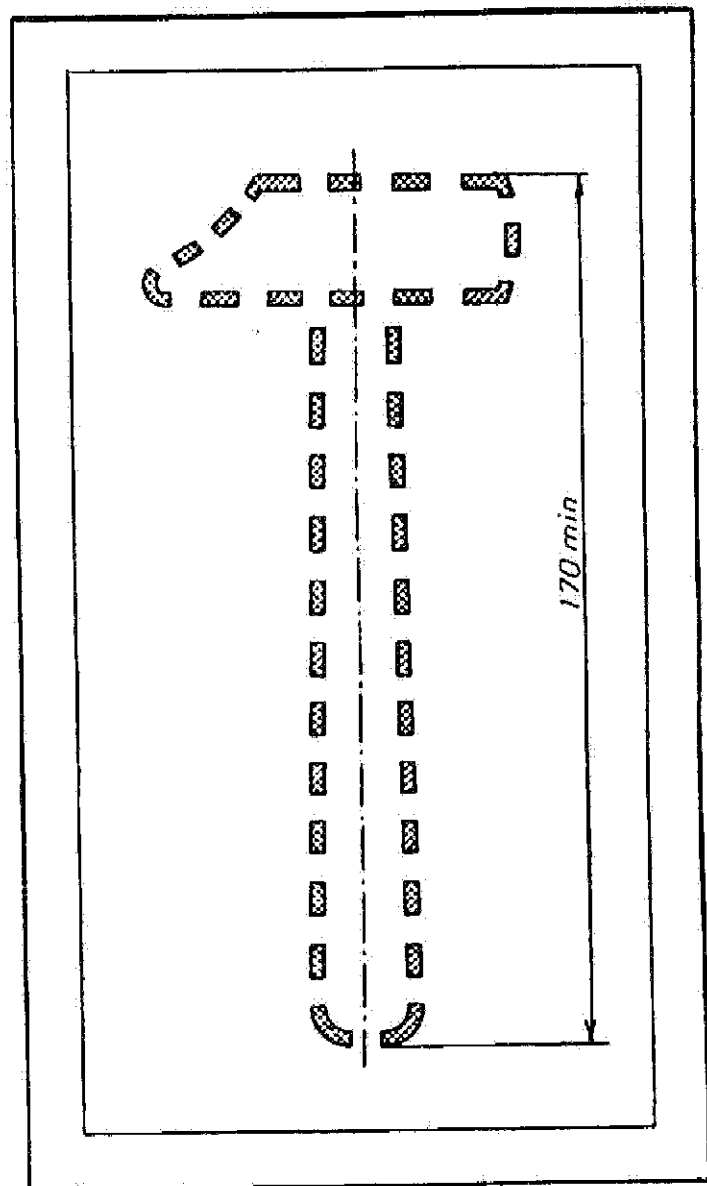
ANNEXE 2  
ANLAGE 2  
APPENDIX 2

Repérage du marteau brise-vitres  
Kennlichmachung des nothammers  
Marking of emergency hammer for  
breaking the windows
